There are two sets of structural information for the Black Bass (A) and (B). Names of the Engineers and their clients have been removed.

The following is structural information (B).

HOTEL/RESTAURANT OBSERVATIONS

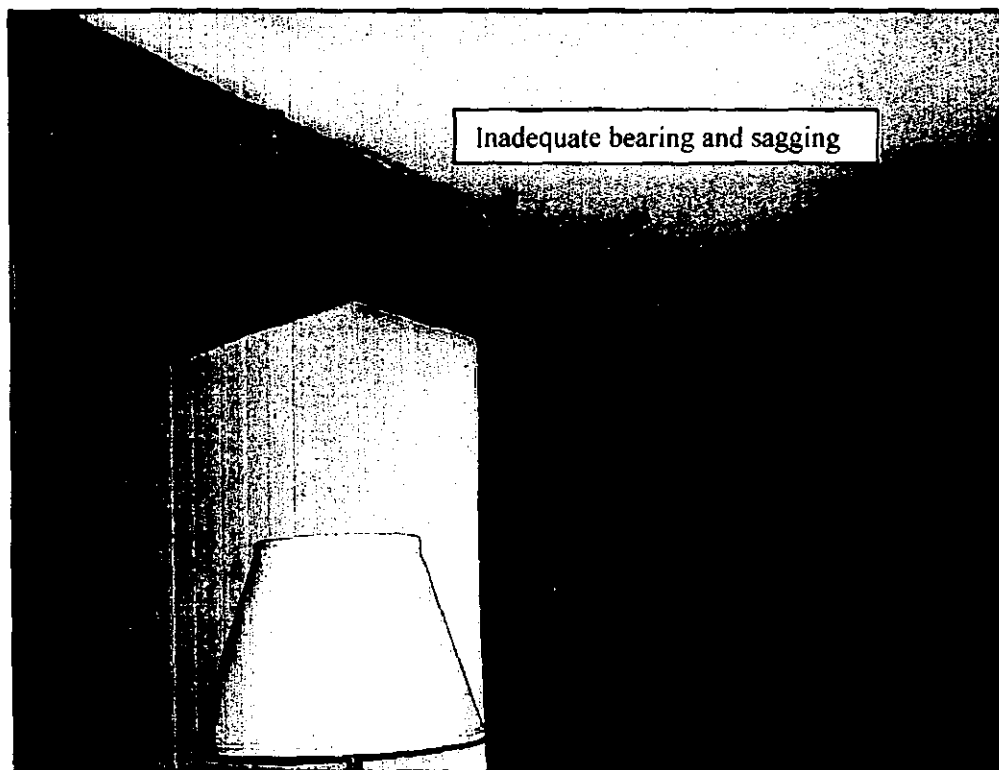
line sagging. We propose that ceiling and wall finishes be removed on both sides of the wall in order to determine the cause of the conditions mentioned above. The probe openings should be large enough to allow head access so that the roof framing can be observed (Photo 3). In addition, rough hewn timber members supporting the ceiling exhibit excessive deflections, inadequate bearing lengths (Photo 3a)

Photo 3a: View of rear bedroom ceiling framing.

B. We recommend that the roof framing and ceilings for the left addition be strengthened to meet the requirements of the Pennsylvania Uniform Construction Code.**

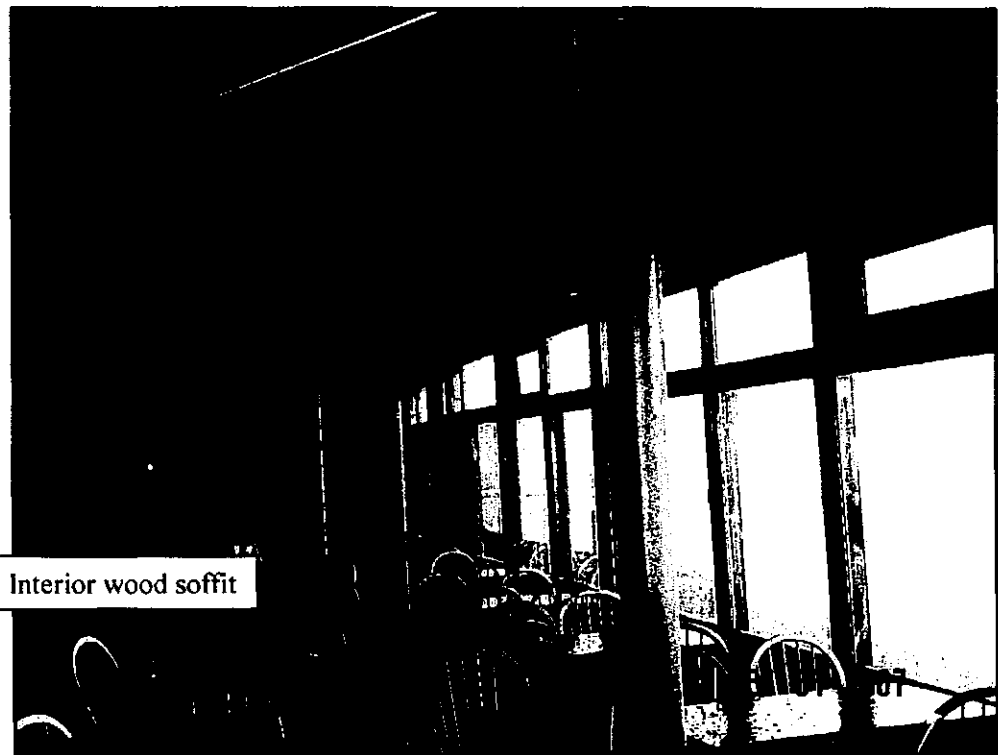
Photo 5: View of interior wood soffit to be removed in first level main dining room

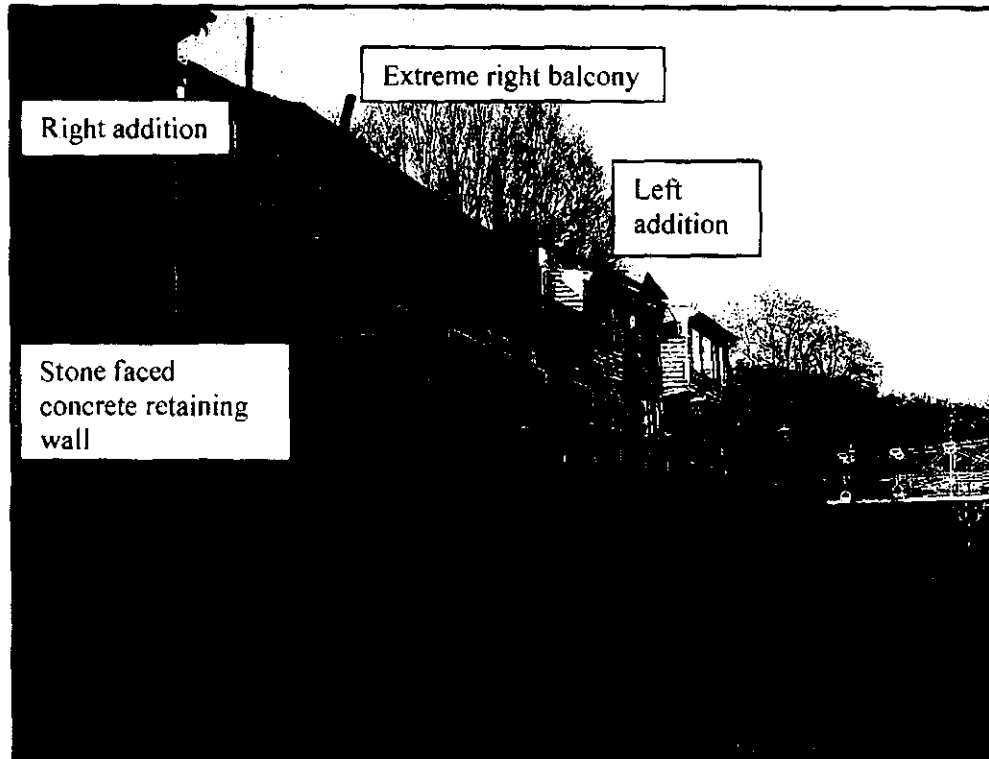
The balcony at the extreme far right end (Photo 6) has sloped down toward the river approximately 3 inches and the railing has pulled away from the exterior face of the building by the same amount.

Photo 6: View of the rear of the building

C. We recommend that the second floor and balcony framing in the rear addition be strengthened or replaced and the floor leveled to meet the requirements of the Pennsylvania Uniform Construction Code.**

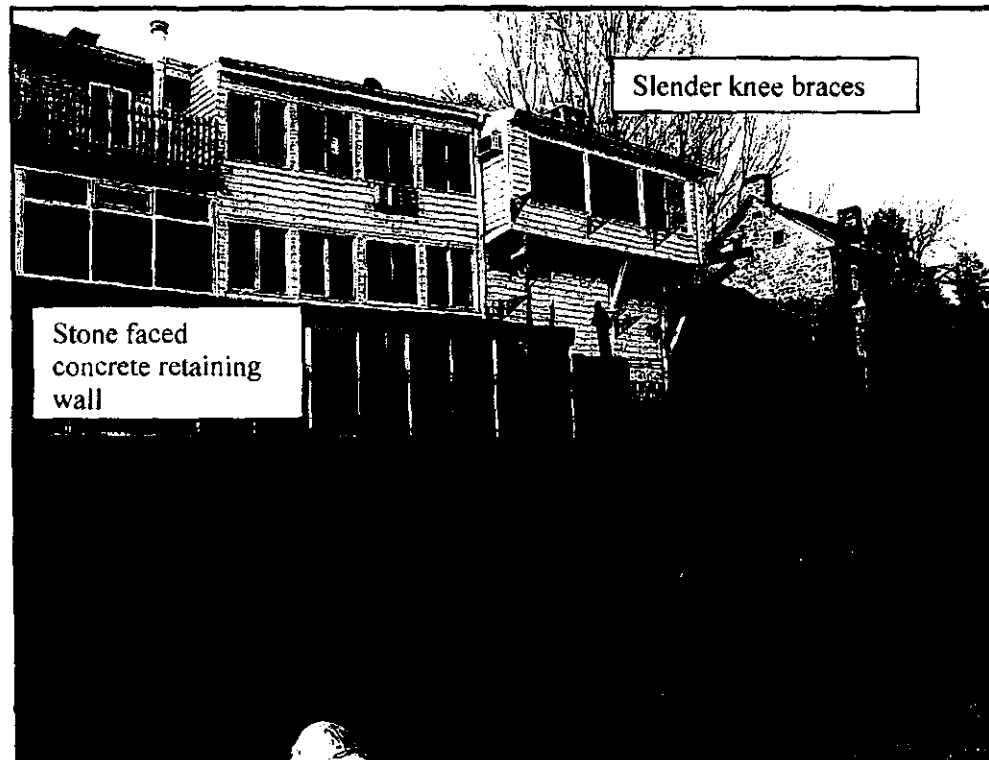
The extreme left rear bedroom of the left addition is cantilevered with a variable cantilever span and is supported by two timber stud knee braces. If these braces are necessary for structural reasons they appear to be too slender to be truly effective. (Photo 7)

Photo 7: View of the left rear of the building

- E. We recommend that the second floor cantilever knee bracing in the left addition be strengthened or replaced to meet the requirements of the Pennsylvania Uniform Construction Code.
- F. We recommend that the entire first floor framing in the original building and newer left addition be strengthened and replaced where necessary and all temporary columns be removed and all permanent columns properly anchored to meet the requirements of the Pennsylvania Uniform Construction Code.
- G. We recommend that the wall material on both sides of the wide diagonal cracks at both ends of the building be removed and replaced with similar material to meet the requirements of the Pennsylvania Uniform Construction Code.
- H. The floor framing within the basement level room in the rear addition may require replacement if the framing is in direct contact with the soil.**

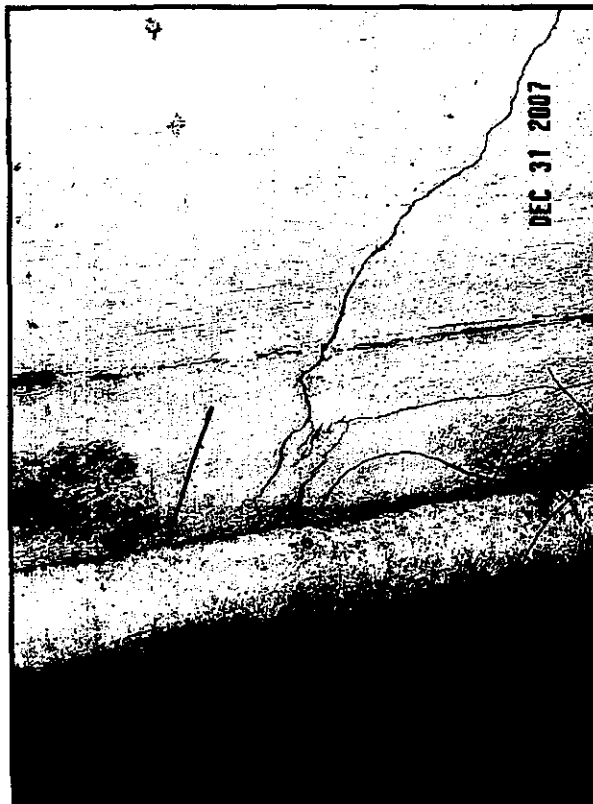
The concrete masonry unit (cmu) foundations of the newer additions have large diagonal cracks wider at the bottom than at the top indicating a slope stability failure causing the supporting soil to move away and down from the building toward the Delaware River. Photo's 17 & 18 show the crack caused by the apparent slope stability failure at the end of the left addition. Photo 19 shows the crack caused by the apparent slope stability failure at the end of the right addition (note that most of the crack is covered by siding).

Photo 17: View of diagonal foundation crack at grade – side of left addition

Photo 18: View of same diagonal crack above at termination – side of left addition
