Inspection Number: 64565a
Inspection Address:
2101 Street Road
Solebury, PA

OUTBUILDINGS

The names of the outbuildings were taken from a lot plan for a proposed subdivision, given to us at the inspection

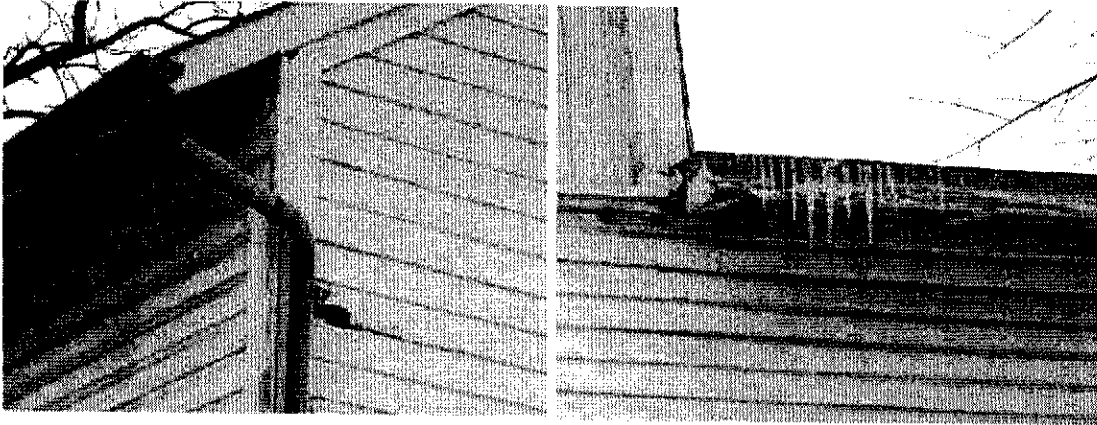
BARN

The lower level is constructed of stone. The stone work and pointing was found to be in satisfactory condition. The upper level is of timber frame construction with wood siding installed. There are repairs needed to the wood siding and fascias/soffits. I recommend any large holes in the siding and damaged wood be repaired. After repairs, I recommend gutters be installed at the rear roof edge.

Visibility of the roof was limited due to snow. Typical of slate roofing systems, cracked, broken, missing or loose slates should be replaced as needed every 1-2 years.

At the timber frame upper level, there has been extensive previous repairs and reinforcement. The repairs included additional framing timbers secured with steel brackets and bolts attached to the old framing. There was also a threaded rod and many cables installed between the front and rear rafter sill plates. There was a large damaged

section of rafter sill that had been reinforced with new wood bolted on to the old wood.

It appears that much of this interior repair and reinforcement was a result of, not only damage from a previously leaking roof, but significant outward movement of the front and rear walls. I did not find any evidence of further movement or separation since the repairs had been performed. There were droppings on the first floor, probably from bats.

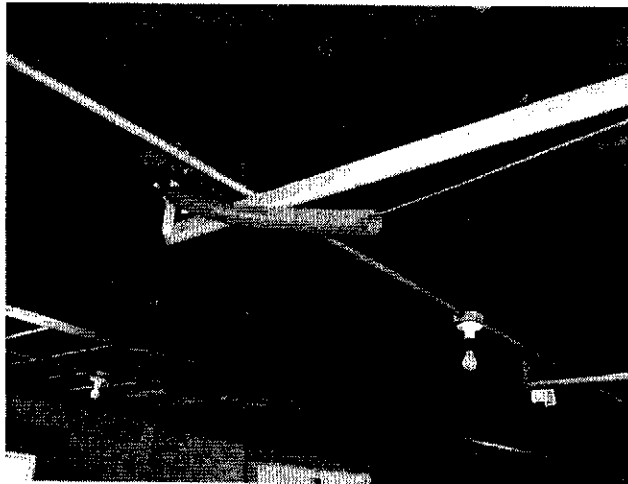
GARAGE/BARN

This building is constructed of concrete block at the lower level and standard frame construction on the upper level. A majority of the slate roof was covered with snow. In one area where the roof was exposed, I found a couple broken slates that need replacement. Again, typical maintenance of a slate roof is to replace any cracked, broken, missing or loose slates every 1-2 years as needed.

On the interior, the visible structure components were found to be satisfactory. The loft at the upper level has traditional wood floor joists and a central steel beam for support. The overhead doors were found to be in working condition except one broken spring needs replacement.

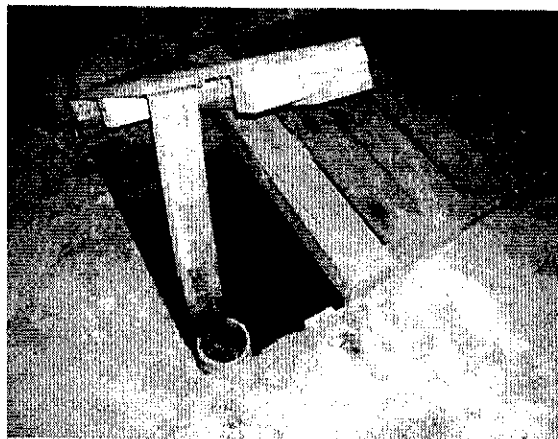
GARAGE 1

This is a one level building, mostly constructed of concrete block. There are two chimneys constructed of

brick. The larger one had a slight lean. The smaller one appears to terminate too close to an adjacent wall and roof structure. If the large chimney is to be used, the liner was found to be in a deteriorated condition. If the smaller chimney is to be used, it may need to be extended to the proper elevation. Currently, the chimneys serve no equipment. The roof was entirely covered with snow and not at all visible for inspection.

It appears this building was used for some type of chemical processing. There was a three-phase 120/240 volt electrical equipment at one time. Much of the equipment has been removed. I recommend a licensed electrician evaluate the electric system and make any changes needed for the new use of this building. I recommend all abandoned electrical components be removed.

There was a pit in the concrete floor of this building. Wood planking was installed above but this wood structure is inadequate to support any significant load. There was also standing water in the pit. Again, I do not know what was being processed in this building if any health or environmental issues are still present.

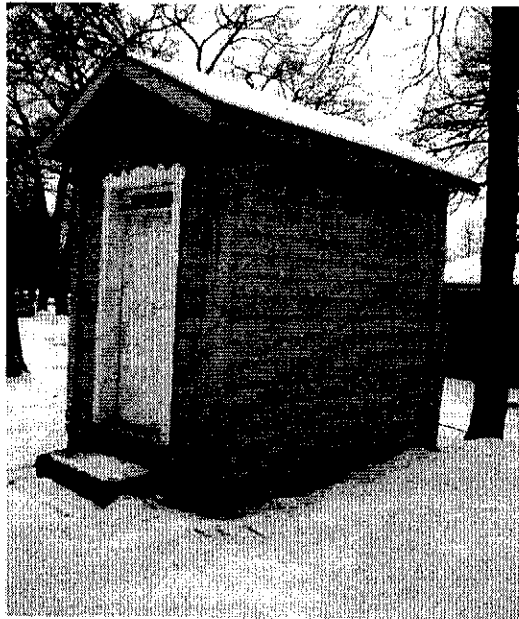
OUTHOUSE

This is a twin, double outhouse of frame construction. There is significant deflection when stepping on the floors of both sides. This small building is supported by four stones in the corners. Underneath three exterior walls, stone fill has been added with a simple trap door on the rear side for access below.

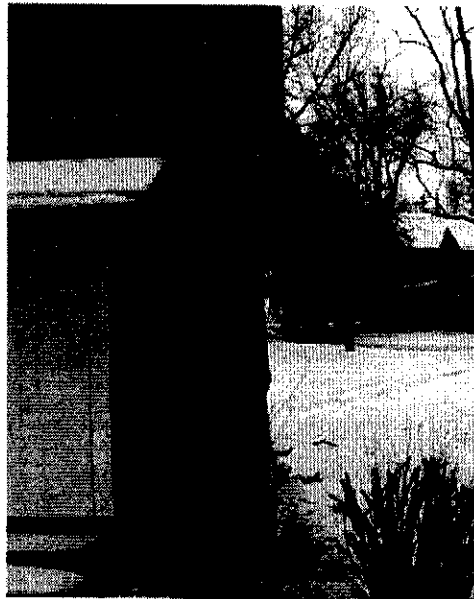
"OUTBUILDING"

The shed is of frame construction using wood clapboard siding. Wood rot was evident to the right side of the entryway as well as to the corner posts. The windows along the right wall were not squared to their opening. The window frames were in satisfactory condition. Any exterior penetrations should be sealed at this time.

The building was found to be lifting towards the left and the interior was found to be completely finished with either drywall and plywood on the first floor and plywood throughout the second floor. No railing was provided leading to the second floor and should be considered for safety purposes. Any broken window panes should be replaced. A concrete slab was installed throughout the first floor and there was evidence of bird droppings

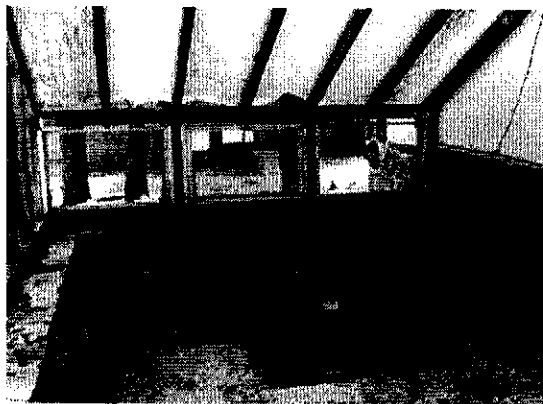
CARPORT/GREENHOUSE

A carport is of masonry construction of both block with a mortar coat and stone was found to be in satisfactory condition. No repairs are required to the exterior. The roof substructure consists of 6x6 posts and beam type construction with 3x4 roof rafters, 1x3 strippers, and cedar roofing. The stains found on the cedar roofing are considered typical. A stone bed was found beneath the roof line. A water source as well as an electric panel were installed for general lighting and power to the greenhouse.

For the green house, the roof system consisted of non-tempered glass and plexiglass. Glass shards were apparent over the pea gravel type bed. A heat source was provided but disconnected. A sump pit was noted with a sump pump, but no power was available. A clock timer was installed to a receptacle where power was evident to this location.

Deterioration was found to the wood framing members with mold accumulation above the triple awning type windows along the left side of the building. Various timers and mechanicals were installed in order to raise the roof line, but could not be tested.
