February 28, 2005  
Report #020528bA

**PROPERTY ADDRESS:**  
**2101 STREET ROAD**  
**NEW HOPE, PA**  
**COTTAGE HOUSE**

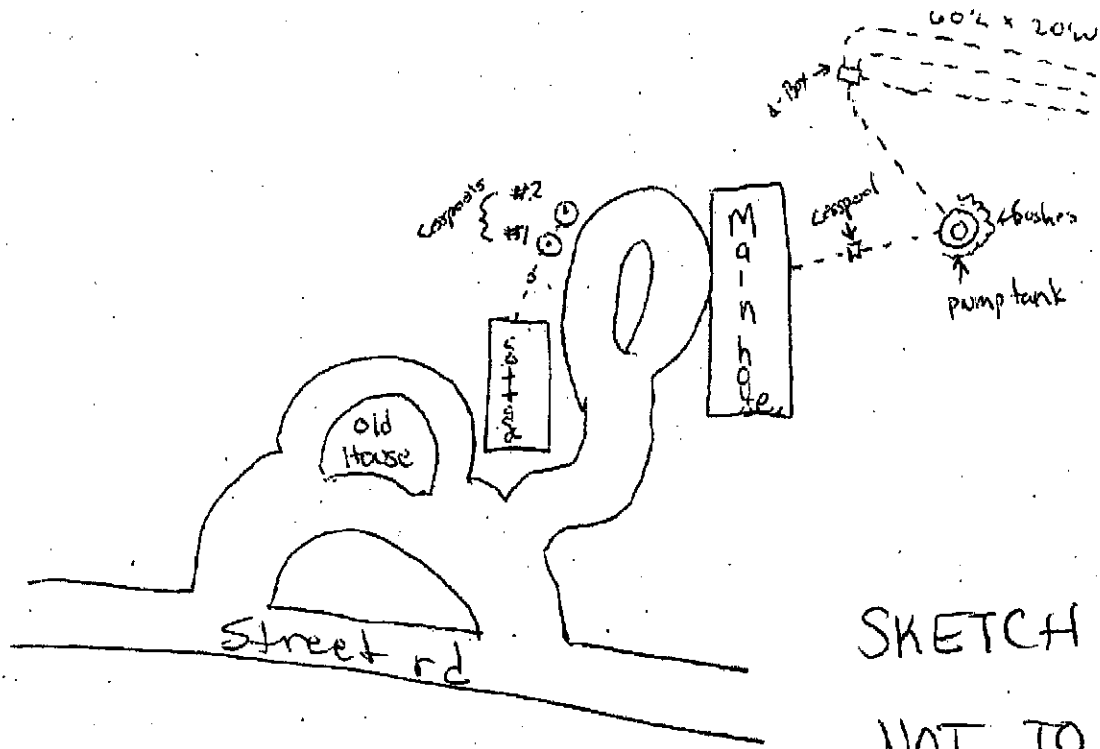
SKETCH ONLY  
NOT TO SCALE

The cesspools appear to be located in the side yard of the cottage next to the driveway. Both cesspools were viewed through six inch pipes extended to grade. The solids content is satisfactory, and a cleaning is not needed at this time. Treatment tanks should be pumped through the main access at least once every two to three years as a preventative maintenance measure to remove the accumulated solids content. The cesspools appeared to be at a satisfactory operating level, as the liquid was below the inlet pipe. All the interior plumbing appears to be connected to the cesspool. Water was run in the dwelling and no signs of sluggish drains were noted.
